Historic Preservation Guidelines
for the **WARFIELD COMPLEX**

Copyright 2002
Town of Sykesville, Maryland

Richard Wagner, AIA, David H. Gleason Associates, Inc., Baltimore, Maryland wrote the *Historic Preservation Guidelines for the Warfield Complex*.

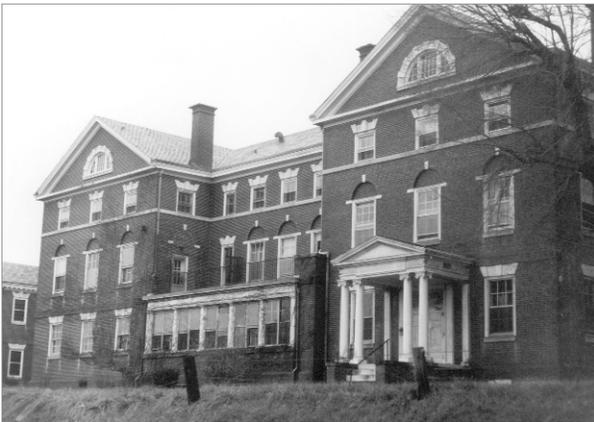
Service Building, north elevation

NORTH ELEVATION CHARACTER-DEFINING FEATURES

- Metal balustrade above roof of projecting porch.
- Storm windows on projecting porch.

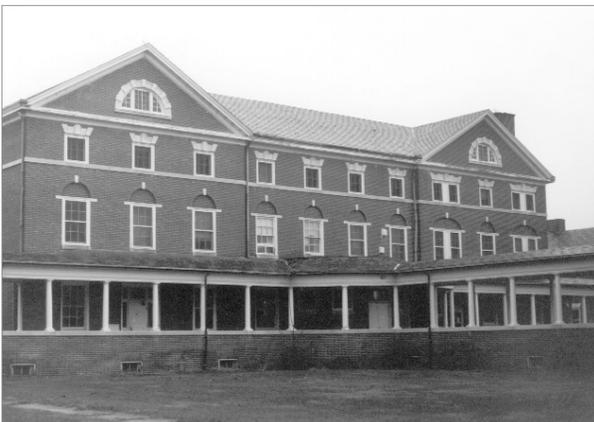
Service Building, south elevation

SOUTH ELEVATION CHARACTER-DEFINING FEATURES

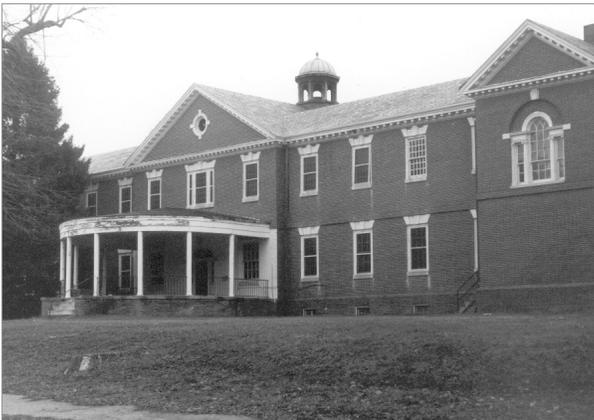
Building C, west elevation

WEST ELEVATION CHARACTER-DEFINING FEATURES

- Semi-circular open porch including marble steps, and entry door, transom and surrounds, except for replacement columns.

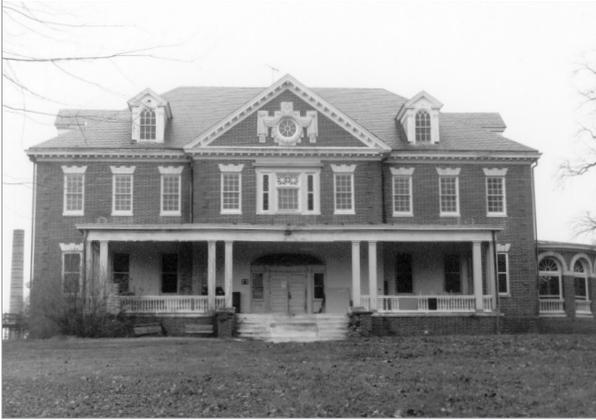
Building W, west elevation

WEST ELEVATION CHARACTER-DEFINING FEATURES

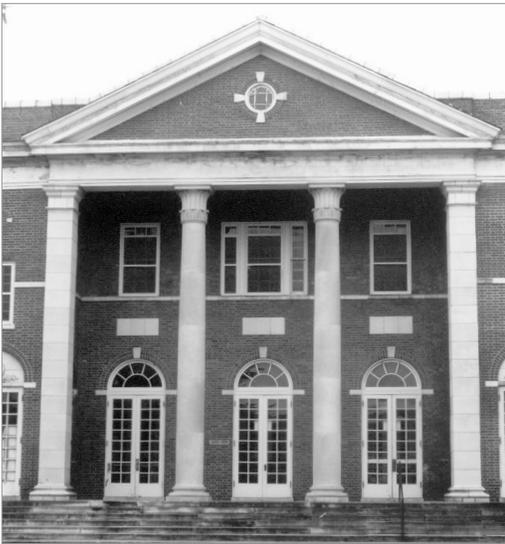
Auditorium, north elevation

NORTH ELEVATION CHARACTER-DEFINING FEATURES

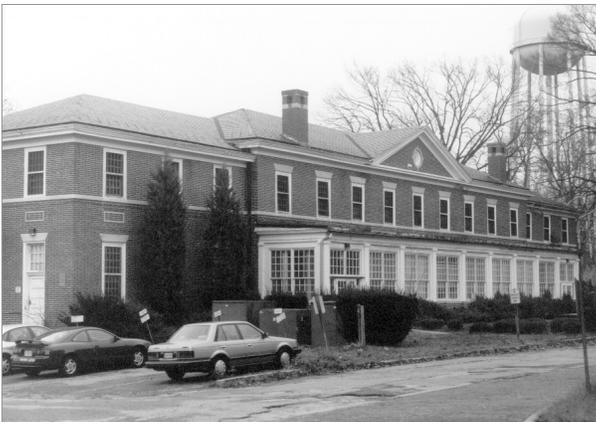
Building E, west elevation

WEST ELEVATION CHARACTER-DEFINING FEATURES

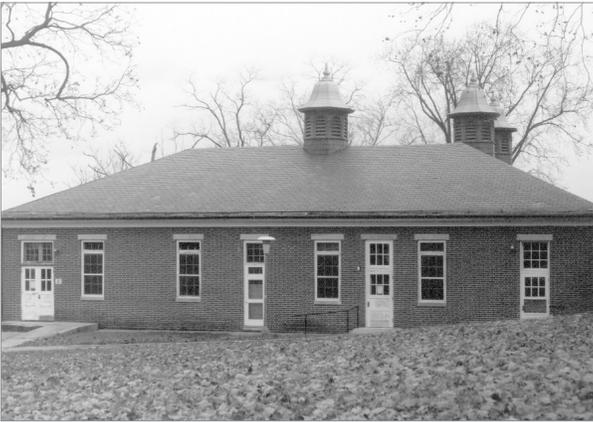
Building H, west elevation

WEST ELEVATION CHARACTER-DEFINING FEATURES

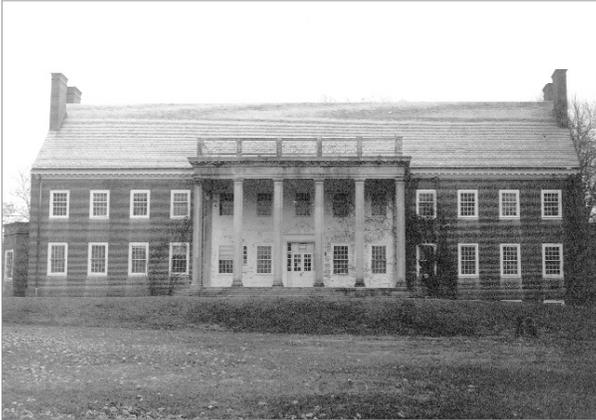
Building I, west elevation

WEST ELEVATION CHARACTER-DEFINING FEATURES

- Two-story, five-bay porch with poured concrete deck supporting six square, paneled Doric limestone columns, limestone entablature, cornice and cast iron balustrade.
- Main entrance including door opening, entablature, sill, surrounds, sidelights and broken pediment.
- Double-hung windows including sash, materials, number of lights, sills, lintels, jack arches and surrounds.
- Flemish bond walls and molded brick water table.

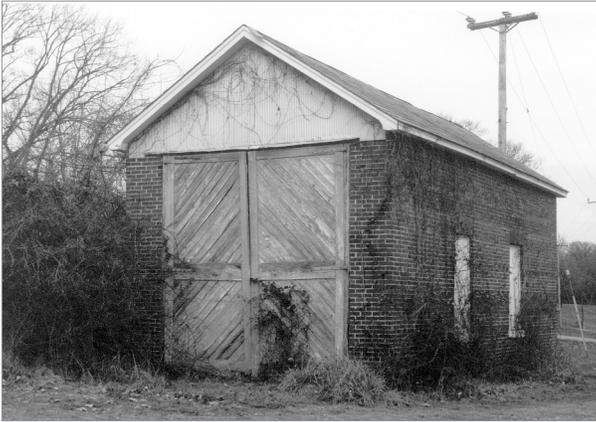
Engine House, south elevation

SOUTH ELEVATION CHARACTER-DEFINING FEATURES

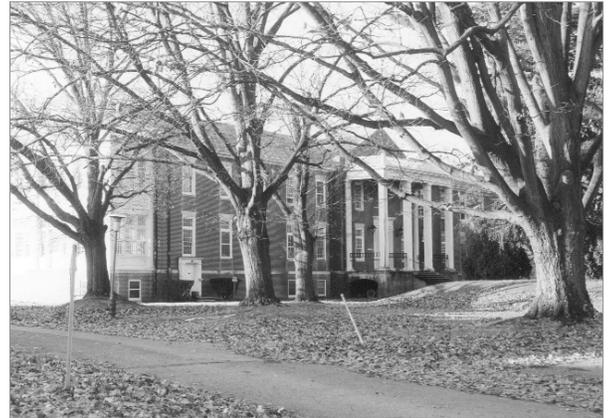
Building T, north elevation

NORTH ELEVATION NON-CHARACTER-DEFINING FEATURES

- Replacement doors and railings.

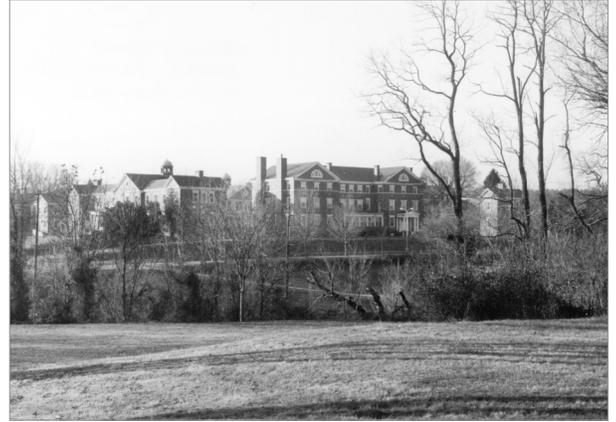
Landscape, near the Service Group

CHARACTER-DEFINING FEATURES

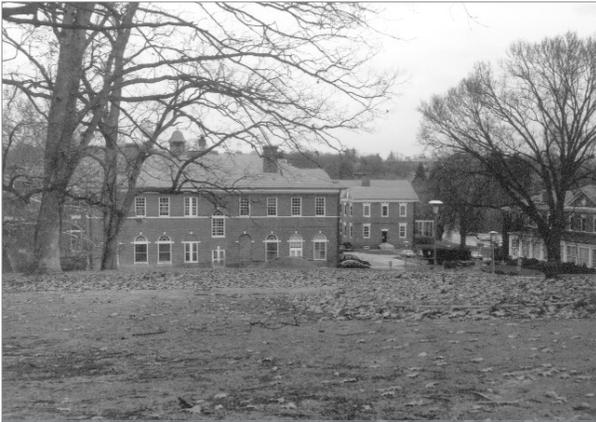
Landscape, near Buildings E, F, I, G, H and the Auditorium

The second quadrangle in the Women's Colony is formed by the Auditorium and Buildings E, F, I, G and H. Unlike the flat northern quadrangle, this open space slopes from the rear of the Auditorium to the rear of Building G. Except for Buildings E and H, none of the buildings have their primary façade facing the quadrangle.
